**Comments of the City of New York on the United States
Environmental Protection Agency's
Draft Monitoring Well Installation Plan for the Gowanus Canal**

April 15, 2010

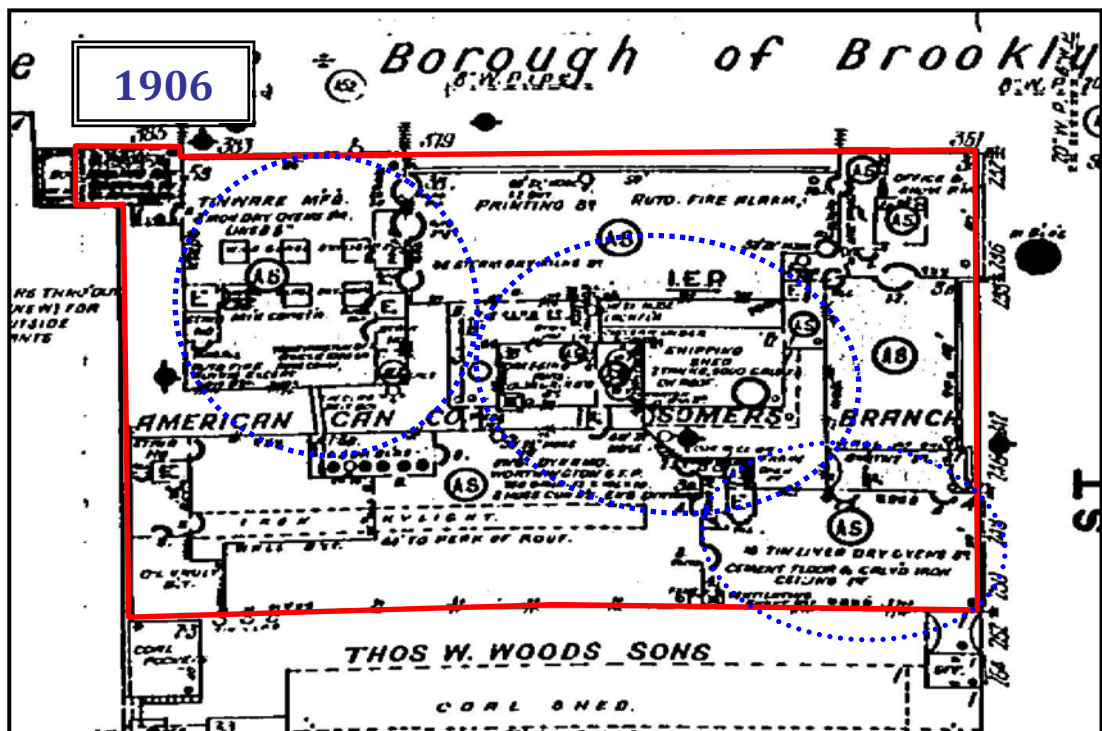
Examples of Significant Environmental Features in Sanborn Maps

Sanborn Map Year	Sanborn Fire Insurance Map Review Industrial Findings	Associated Potential Environmental Concern
1888	Somers Bros. Decorated Tinware	Various petroleum products, solvents, paint, and heavy metals could be stored and used at the former iron furniture manufacturer. Potential contaminants include metal compounds (tin, copper, lead, zinc, etc.), cresol, PAHs, sulfuric and other acids, phenol, xylene, and various chlorinated solvents.
1906	American Can Company, Somers Branch – tinware manufacturing; painting; shipping; offices.	Various petroleum products, solvents, paint, and heavy metals could be stored and used at the former iron furniture manufacturer. Potential contaminants include metal compounds (tin, copper, lead, zinc, etc.), cresol, PAHs, sulfuric and other acids, phenol, xylene, and various chlorinated solvents.
1951	Owners – American Can. Metropolitan Ware House – lofts; storage; boiler room; drying ovens.	Various petroleum products, solvents, paint, and heavy metals could be stored and used at the former iron furniture manufacturer. Potential contaminants include metal compounds (tin, copper, lead, zinc, etc.), cresol, PAHs, sulfuric and other acids, phenol, xylene, and various chlorinated solvents.

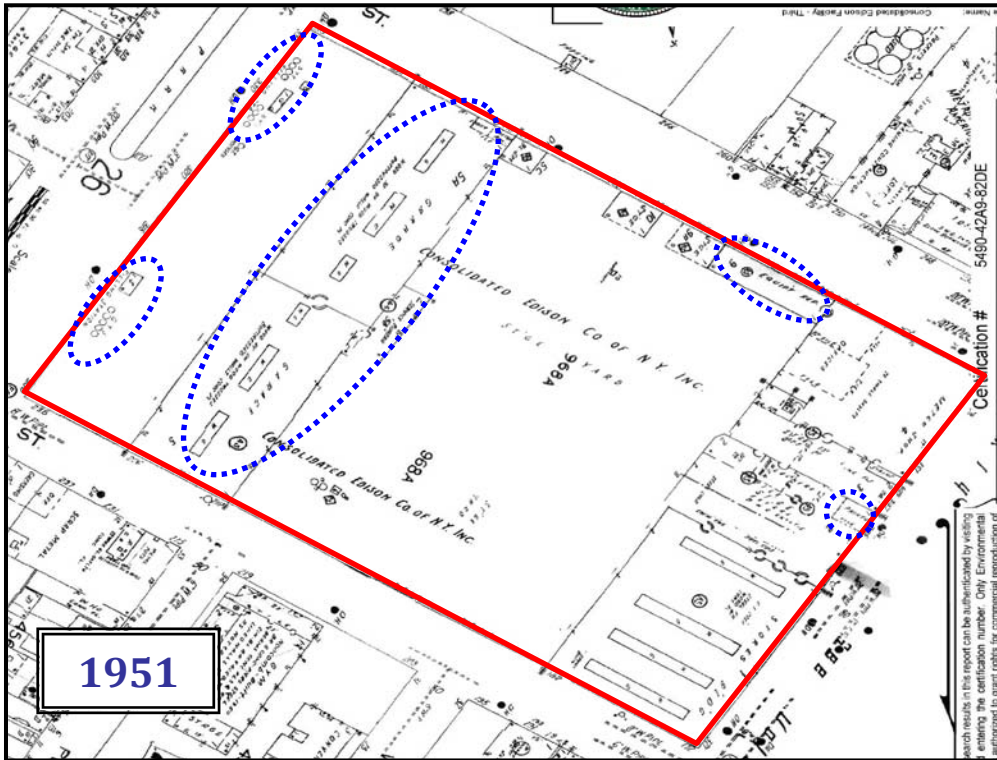
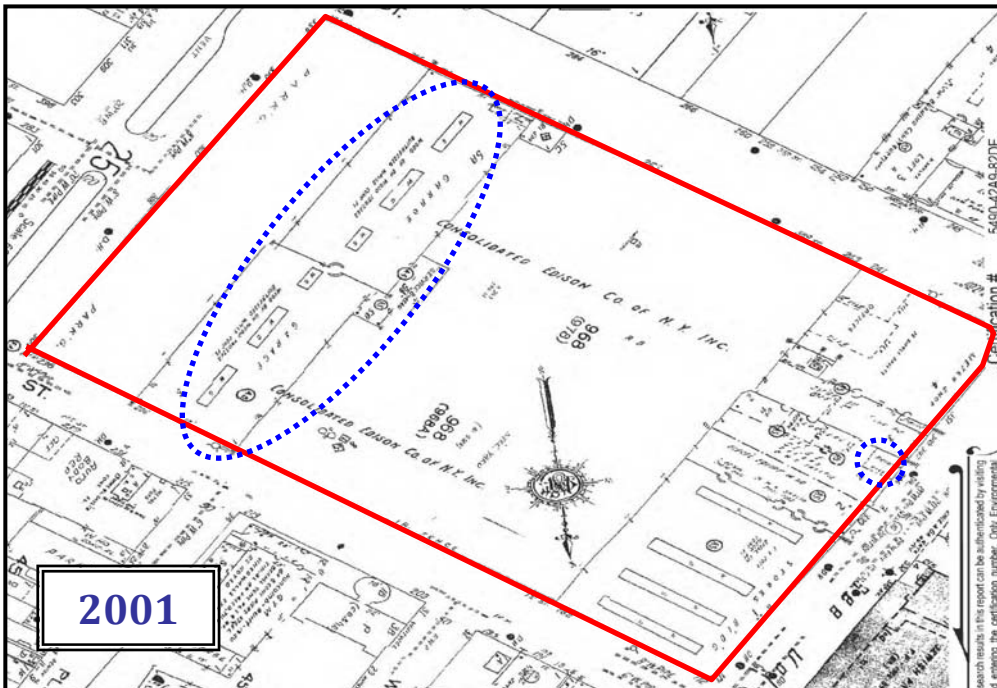
Examples of Significant Environmental Features in Sanborn Maps

1965-1988	Consolidated Edison Co of NY, Inc. Service Bureau: meter shop, offices, storage, lockers, electrical equipment warehouse, stores building, two garages, two sheds, blacksmith, parking lots, equipment repair; one unused gasoline tank; two additional gasoline tanks in yard.	A large amount of gasoline was probably stored and used at the property. Potential contaminants include benzene, toluene, xylene, phenol, methyl isobutyl ketone, methyl chloroform, ethylene dichloride, methylene chloride, methanol, creosote, lead, mercury, copper, and PAHs.
1991-2007	Consolidated Edison Co of NY, Inc. Service Bureau: meter shop, offices, storage, lockers, electrical equipment warehouse, stores building, two garages, two sheds, blacksmith, parking lots, one unused gasoline tank; two additional gasoline tanks in yard.	A large amount of gasoline was probably stored and used at the property. Potential contaminants include benzene, toluene, xylene, phenol, methyl isobutyl ketone, methyl chloroform, ethylene dichloride, methylene chloride, methanol, creosote, lead, mercury, copper, and PAHs.

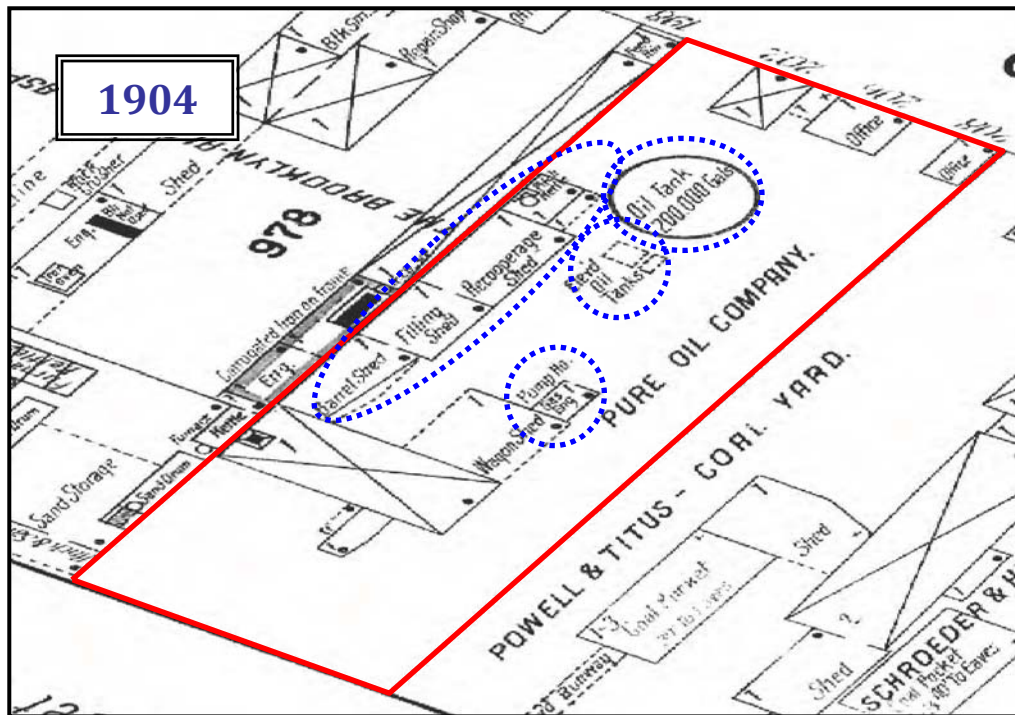
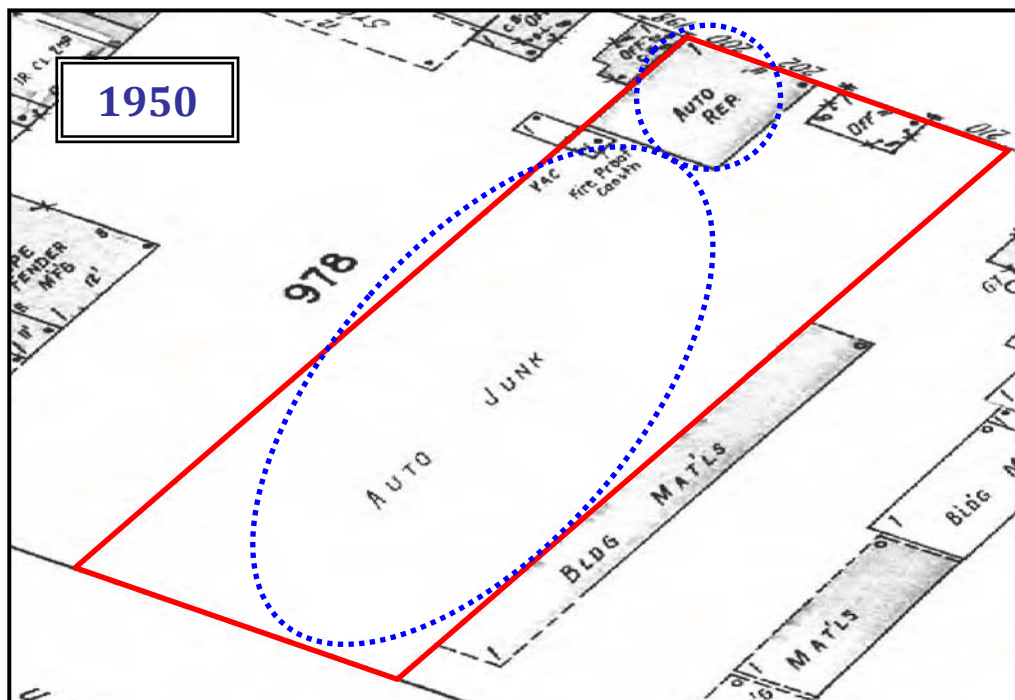
Examples of Significant Environmental Features in Sanborn Maps

1950	Auto repair and junkyard with office building.	Petroleum products, solvents, and paint were probably used at this former auto repair and junkyard company. Potential contaminants include benzene, toluene, xylene, phenol, methyl isobutyl ketone, methyl chloroform, ethylene dichloride, methylene chloride, methanol, creosote, lead, mercury, copper, and PAHs.
1969-2005	Auto repair facility, tile products storage.	Petroleum products, solvents, and paint were probably used at this former auto repair and junkyard company. Potential contaminants include benzene, toluene, xylene, phenol, methyl isobutyl ketone, methyl chloroform, ethylene dichloride, methylene chloride, methanol, creosote, lead, mercury, copper, and PAHs.

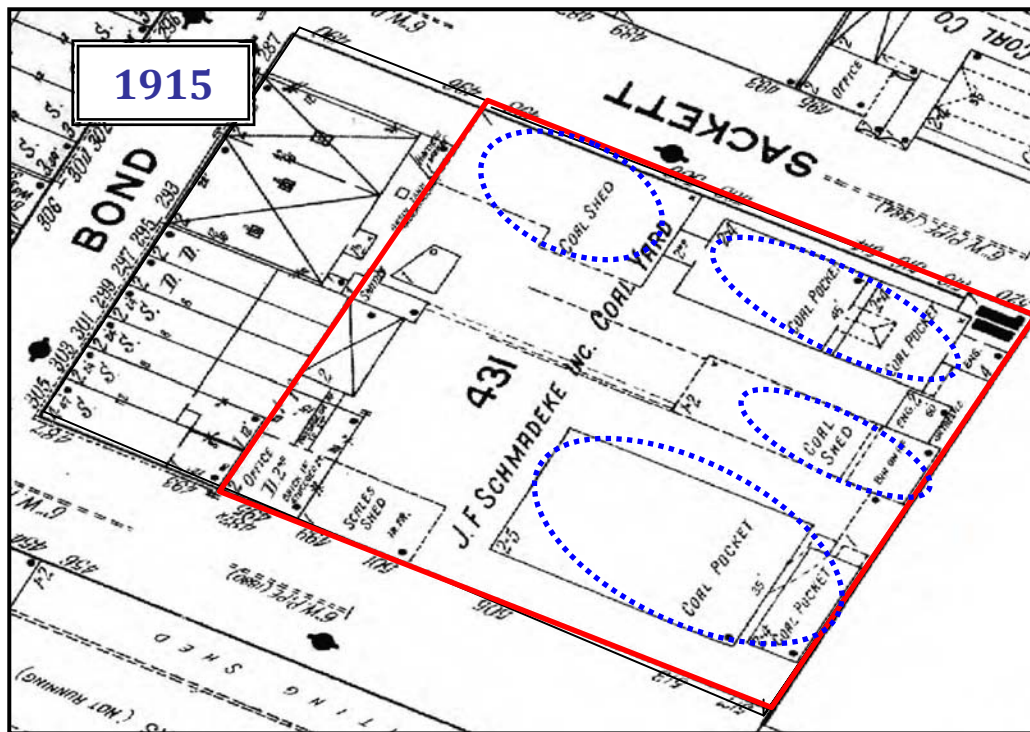
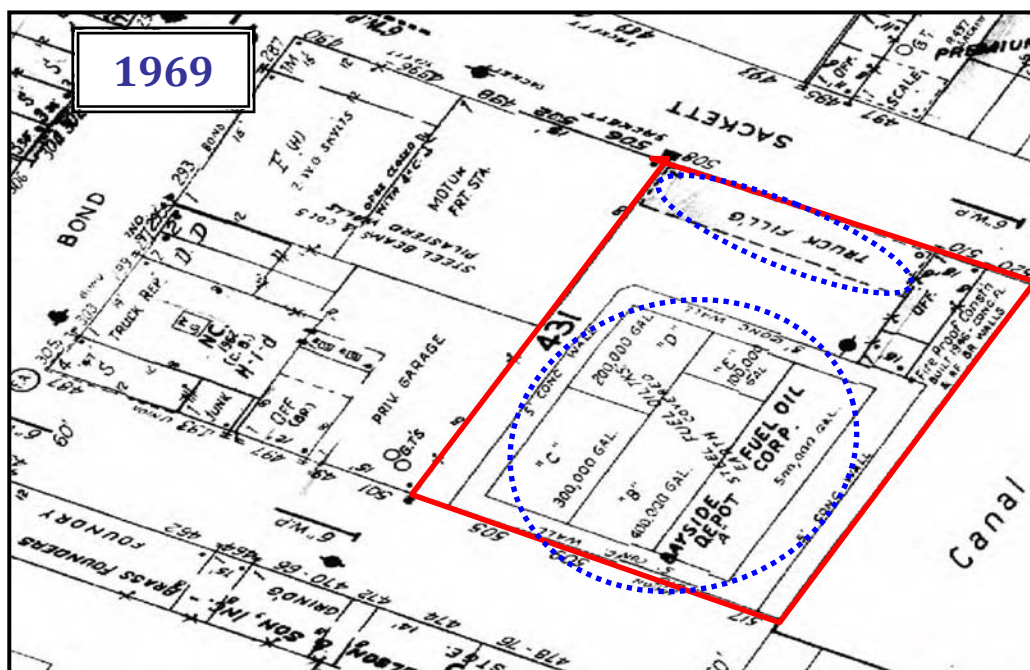
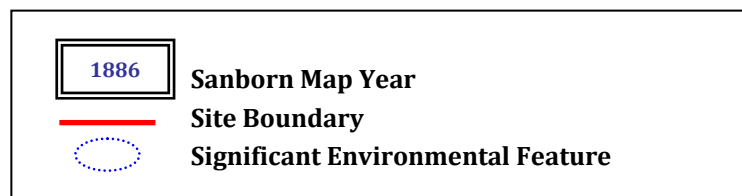
Examples of Significant Environmental Features in Sanborn Maps

Sanborn Map Year	Sanborn Fire Insurance Map Review Industrial Findings	Associated Potential Environmental Concern
1950	Supreme Oil Terminal Corp.: Two private garages; two auto repair facilities, one with two gasoline tanks; steel fuel oil tanks (earth-covered) in the following capacities: one 500,000-gallon; one 400,000-gallon; one 300,000-gallon; one 200,000-gallon; and one 100,000-gallon; all encased by a 5' concrete wall; offices; truck filling area; motor freight station.	A large amount of fuel oil and solvent were stored and used at the property. Potential contaminants include benzene, toluene, xylene, phenol, methyl isobutyl ketone, methyl chloroform, ethylene dichloride, methylene chloride, methanol, creosote, lead, mercury, copper, and PAHs.
1969- 2007	Bayside Fuel Oil Depot Corp.: Two private garages; two auto/truck repair facilities; steel fuel oil tanks (earth-covered) in the following capacities: one 500,000-gallon; one 400,000-gallon; one 300,000-gallon; one 200,000-gallon; and one 100,000-gallon; all encased by a 5' concrete wall; offices; truck filling area; motor freight station; junkyard.	A large amount of fuel oil and solvent were stored and used at the property. Potential contaminants include benzene, toluene, xylene, phenol, methyl isobutyl ketone, methyl chloroform, ethylene dichloride, methylene chloride, methanol, creosote, lead, mercury, copper, and PAHs.

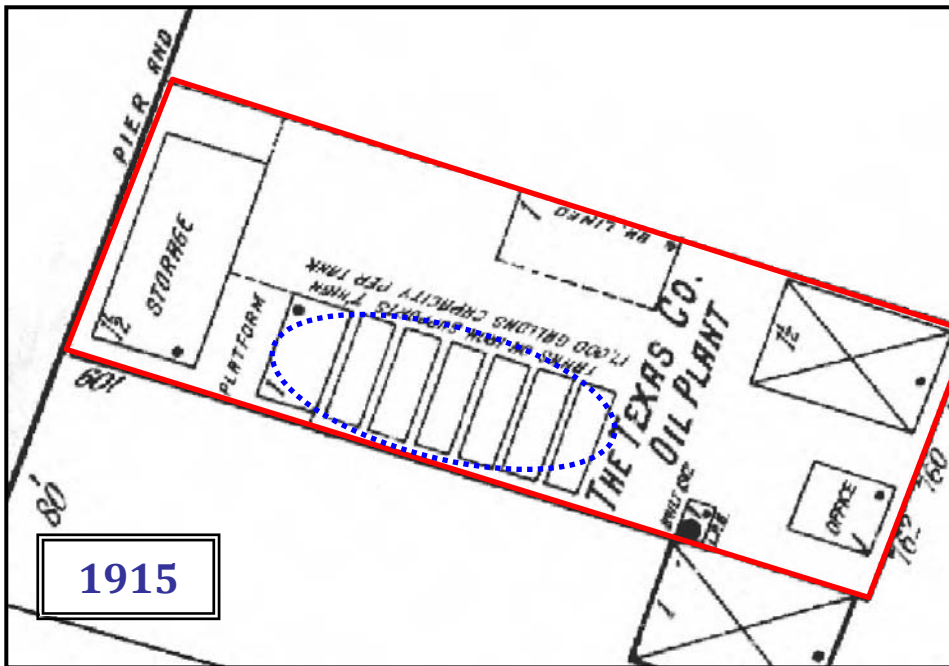
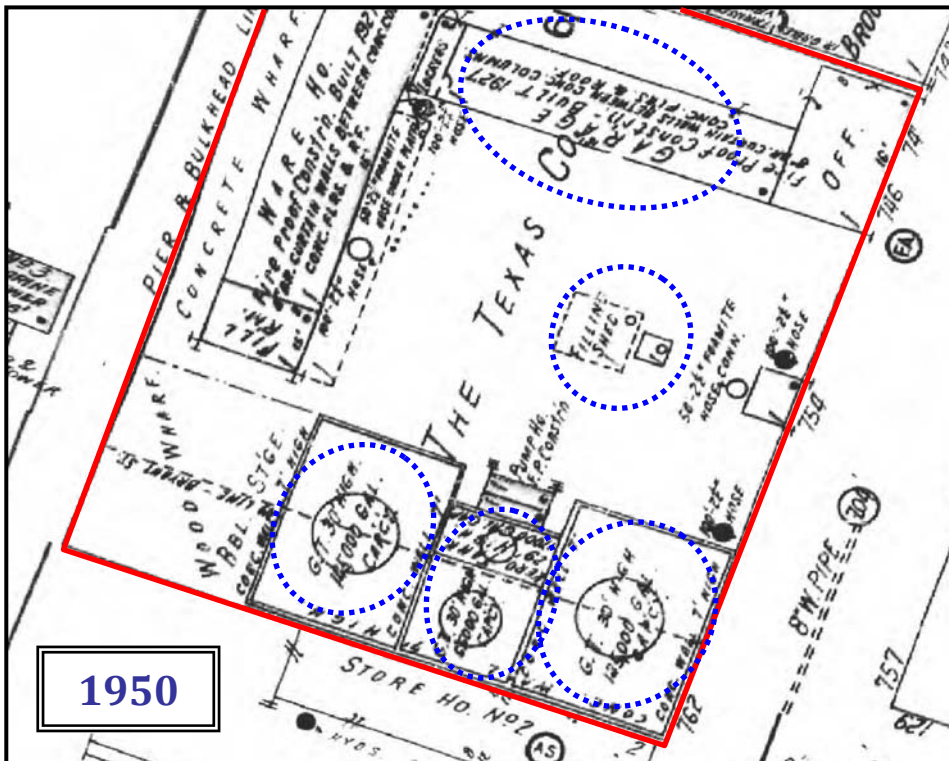
Examples of Significant Environmental Features in Sanborn Maps

1969	All tanks listed as empty; Aid Export Trucking – warehouses, office, garage.	Petroleum products and solvents were probably used at this former trucking company.
1977-1988	Tanks no longer shown (replaced by a warehouse and a building of concrete construction); Aid Export Trucking warehouse.	Petroleum products and solvents were probably used at this former trucking company.
1991-2007	American Stevedoring Ltd. Import-Export Trucking.	Petroleum products and solvents were probably used at this former trucking company.

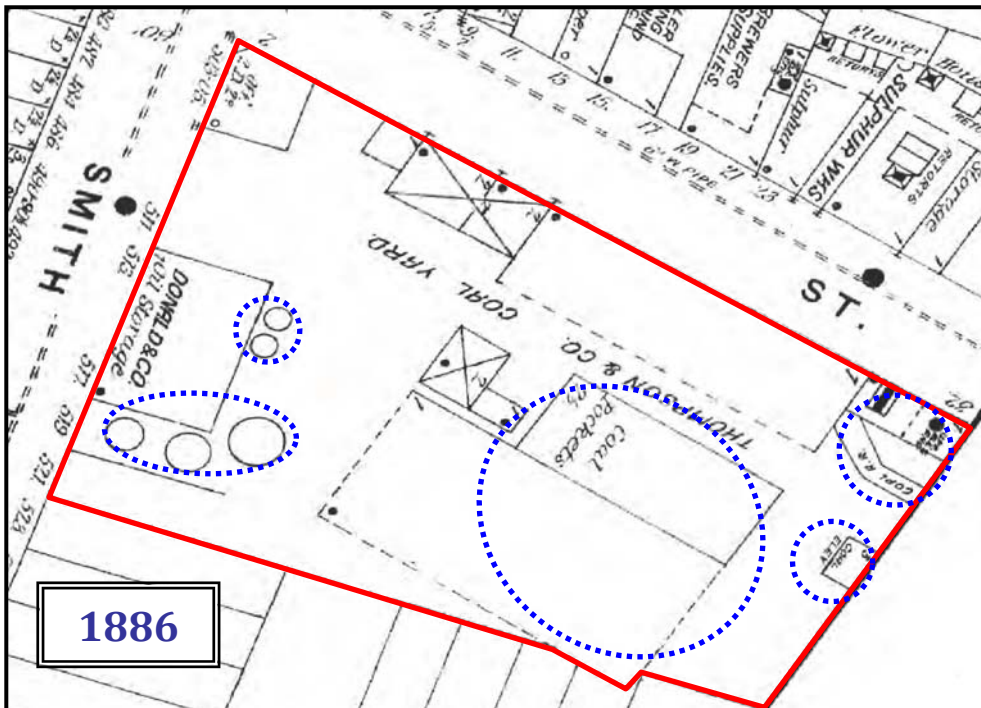
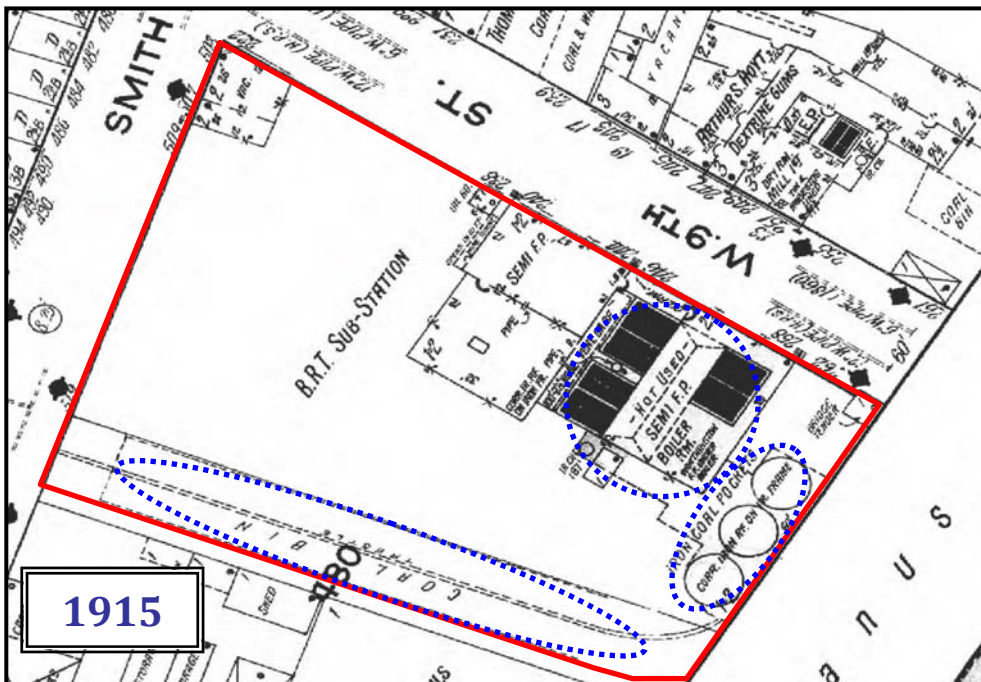
Examples of Significant Environmental Features in Sanborn Maps

Sanborn Map Year	Sanborn Fire Insurance Map Review Industrial Findings	Associated Potential Environmental Concern
1950	Crate, marine equipment, and rope storage buildings, auto repair, parking, generator room.	Petroleum products and solvents were probably used during auto repair activities. Potential contaminants include benzene, toluene, xylene, phenol, methyl isobutyl ketone, methyl chloroform, ethylene dichloride, methylene chloride, methanol, creosote, lead, mercury, copper, and PAHs.
1969-2007	Filling station.	A large amount of fuel oil was stored and used at this former oil company. Potential contaminants include benzene, toluene, xylene, phenol, methyl isobutyl ketone, methyl chloroform, ethylene dichloride, methylene chloride, methanol, creosote, lead, mercury, copper, and PAHs.

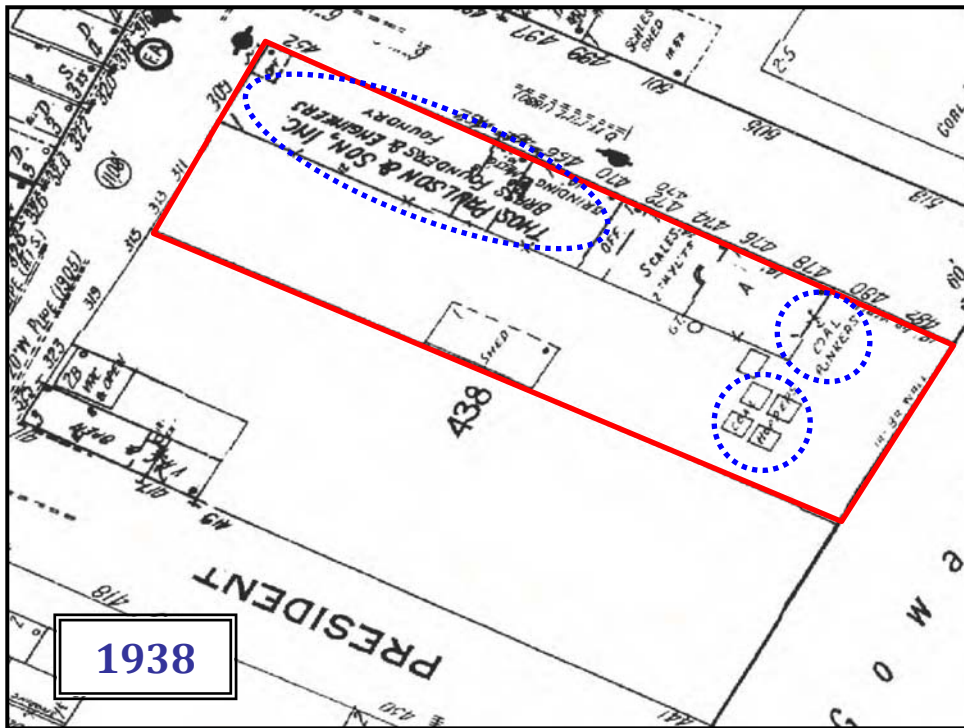
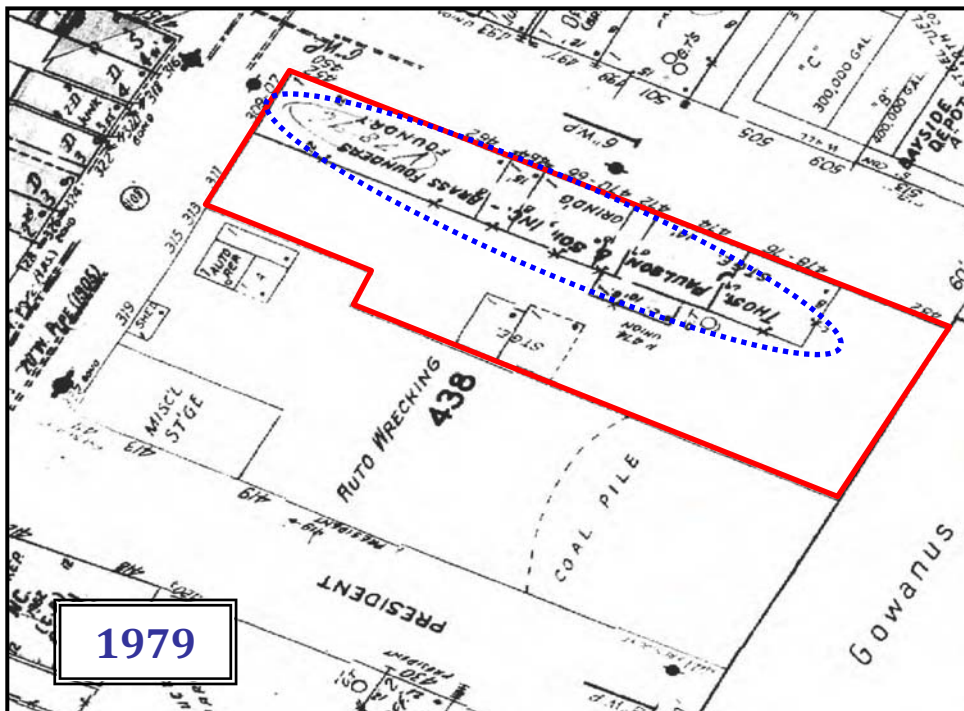
Examples of Significant Environmental Features in Sanborn Maps

Sanborn Map Year	Sanborn Fire Insurance Map Review Industrial Findings	Associated Potential Environmental Concern
1950	Thos Paulson & Son, Inc. Brass Founders & Engineers: Foundry; storage and shed buildings.	Various petroleum products, solvents, and heavy metals could be stored and used at the former foundry. Potential contaminants include zinc, chromium, lead, copper, manganese, methanol, PAHs, sulfuric and other acids, phenol, xylene, and various chlorinated solvents.
1969- 1979	Thos Paulson & Son, Inc. Brass Founders & Engineers: Foundry; storage and shed buildings, and gasoline tank.	Various petroleum products, solvents, and heavy metals could be stored and used at the former foundry. Potential contaminants include zinc, chromium, lead, copper, manganese, methanol, PAHs, sulfuric and other acids, phenol, xylene, and various chlorinated solvents.
1980- 2007	Thos Paulson & Son, Inc. Brass Founders & Engineers: Foundry; storage and shed buildings, and gasoline tank.	Various petroleum products, solvents, and heavy metals could be stored and used at the former foundry. Potential contaminants include zinc, chromium, lead, copper, manganese, methanol, PAHs, sulfuric and other acids, phenol, xylene, and various chlorinated solvents.

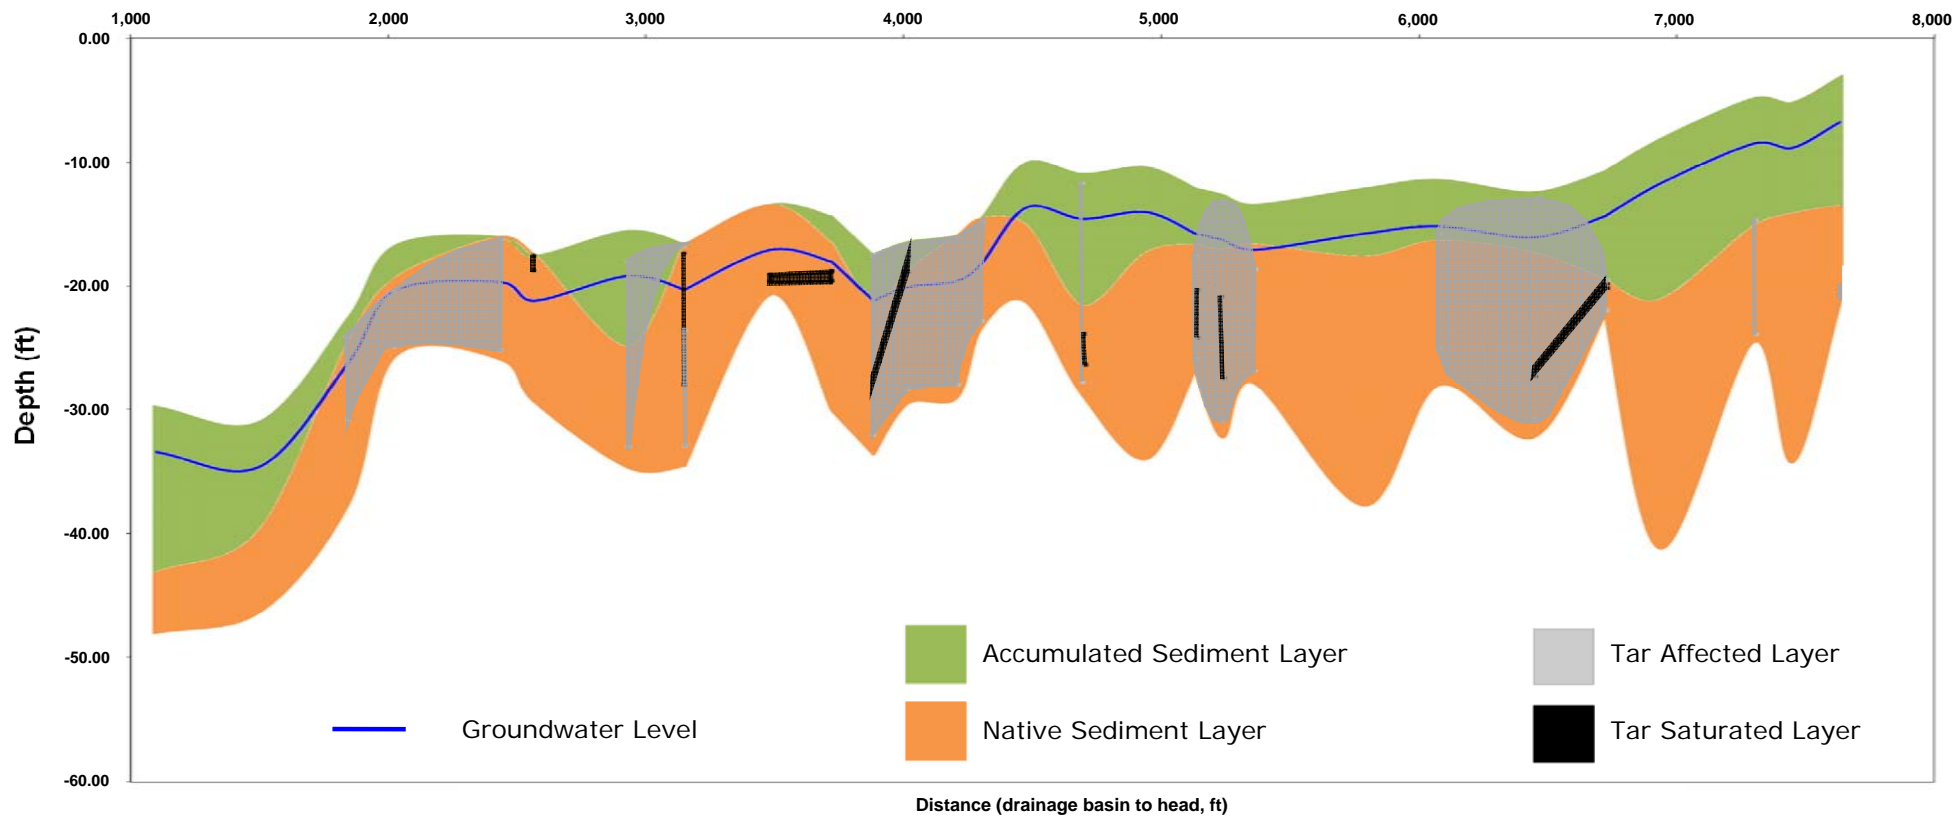
Figure 4 - Gowanus Canal Centerline Cross Section

The glacial outwash deposits described above, when saturated, comprise the Upper Glacial Aquifer. This hydrostratigraphic unit is the main aquifer underlying the Canal and surrounding uplands. This unit is generally unconfined (water table); however, it can be locally confined by the presence of silt and clay layers of alluvial and marsh deposits. Regional groundwater flow within the deeper portions of the Upper Glacial Aquifer is to the west to southwest towards Upper New York Harbor. Shallow groundwater flow within the fill unit, alluvial/marsh deposits and upper portions of the glacial deposits in the upland area surrounding the Canal is towards the Canal. Figure 2a is a USGS Potentiometric Surface/Groundwater Elevation Contour Map (USGS, 2006) for the Upper Glacial deposits for 2006. The USGS 2006 Groundwater Contour Map did not present the 5-foot MSL groundwater contour; however, this contour was inferred from the USGS monitoring well data.

within these deposits can be on the order of 0.5-1.0 foot per day. The alluvial/marsh deposits of the Upper Glacial Aquifer are typically less permeable than the underlying glacial deposits and may create locally confined conditions where present (Busciolano, 2002).

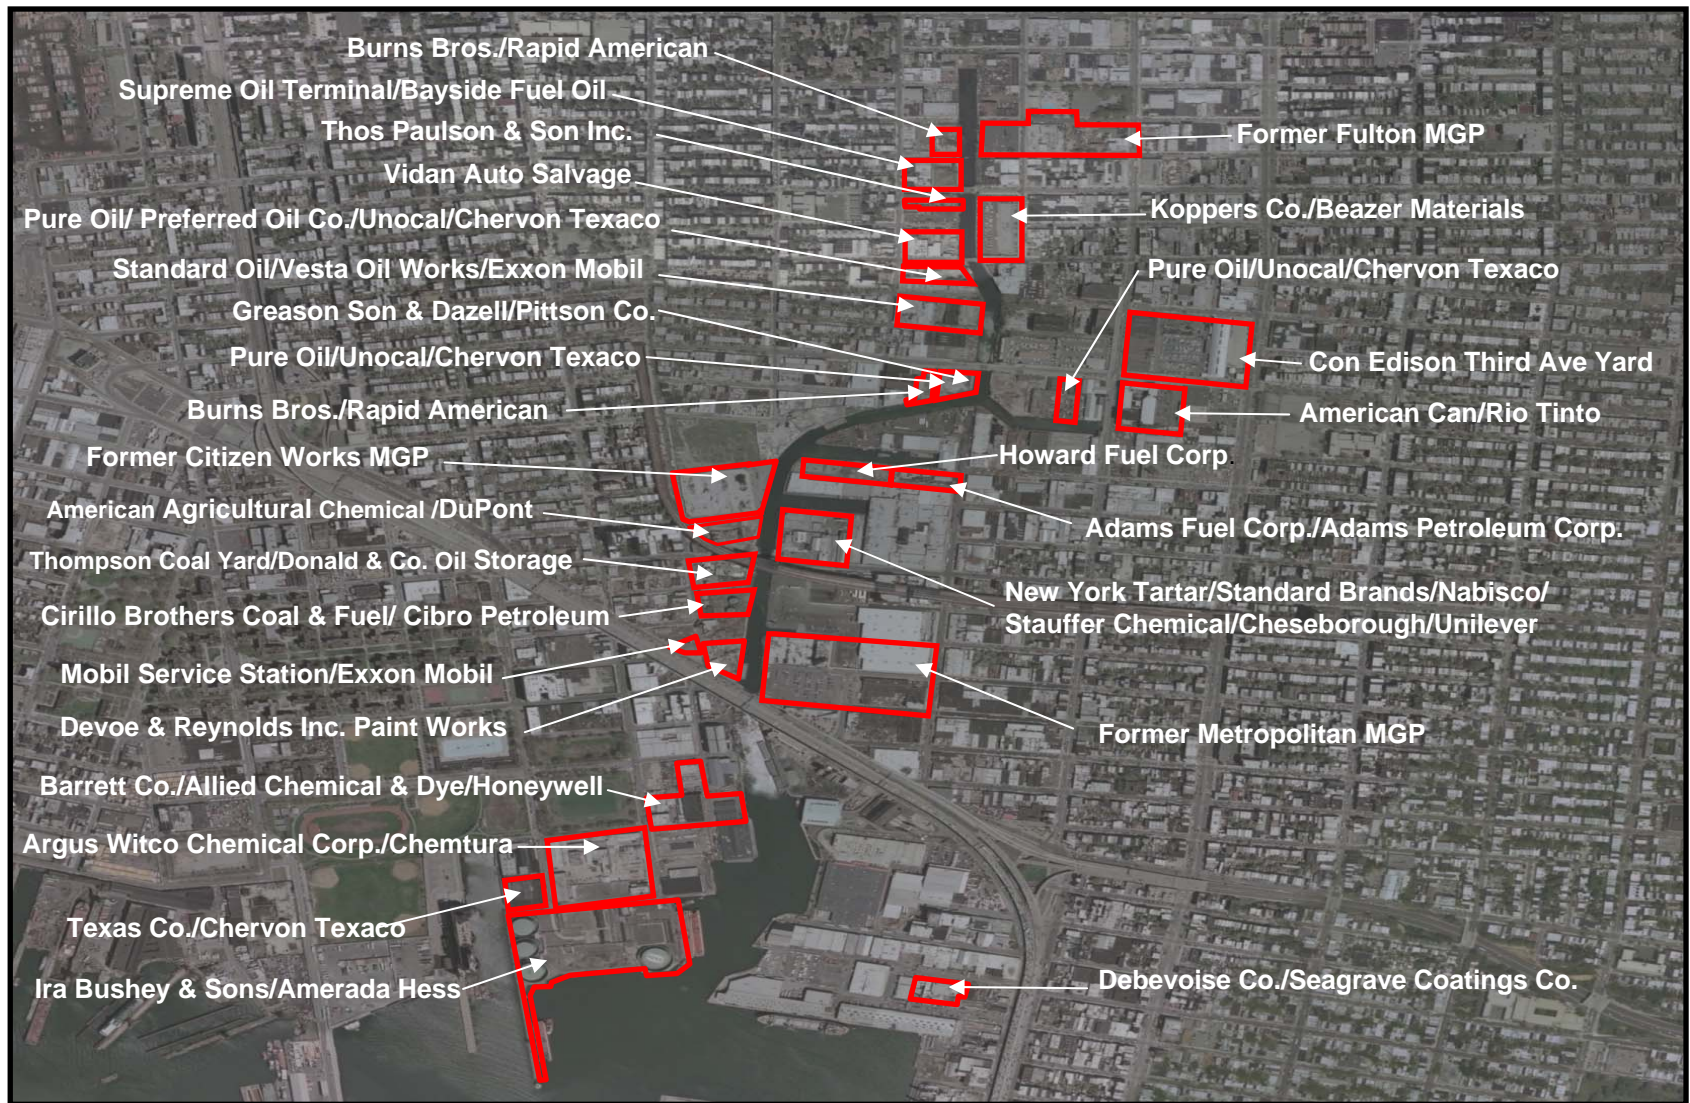
Figure 5 - High Priority Upland Industrial Properties Around Gowanus Canal

In addition, the City conducted a comprehensive review of historical and modern maps and reports and identified several dozens other upland properties with either a known or a high potential for ongoing discharges of hazardous waste and/or petroleum to the Canal. Individual profiles of these identified upland industrial properties are described further in section 4.1.5 of this document. The City notes that many of these potential upland industrial sources of contamination are at present, largely uncharacterized, as is the distribution of contaminants in soils, surface water and groundwater. These uncharacterized properties and contaminants threaten the long-term effectiveness of any proposed remedy through the risk of recontamination.

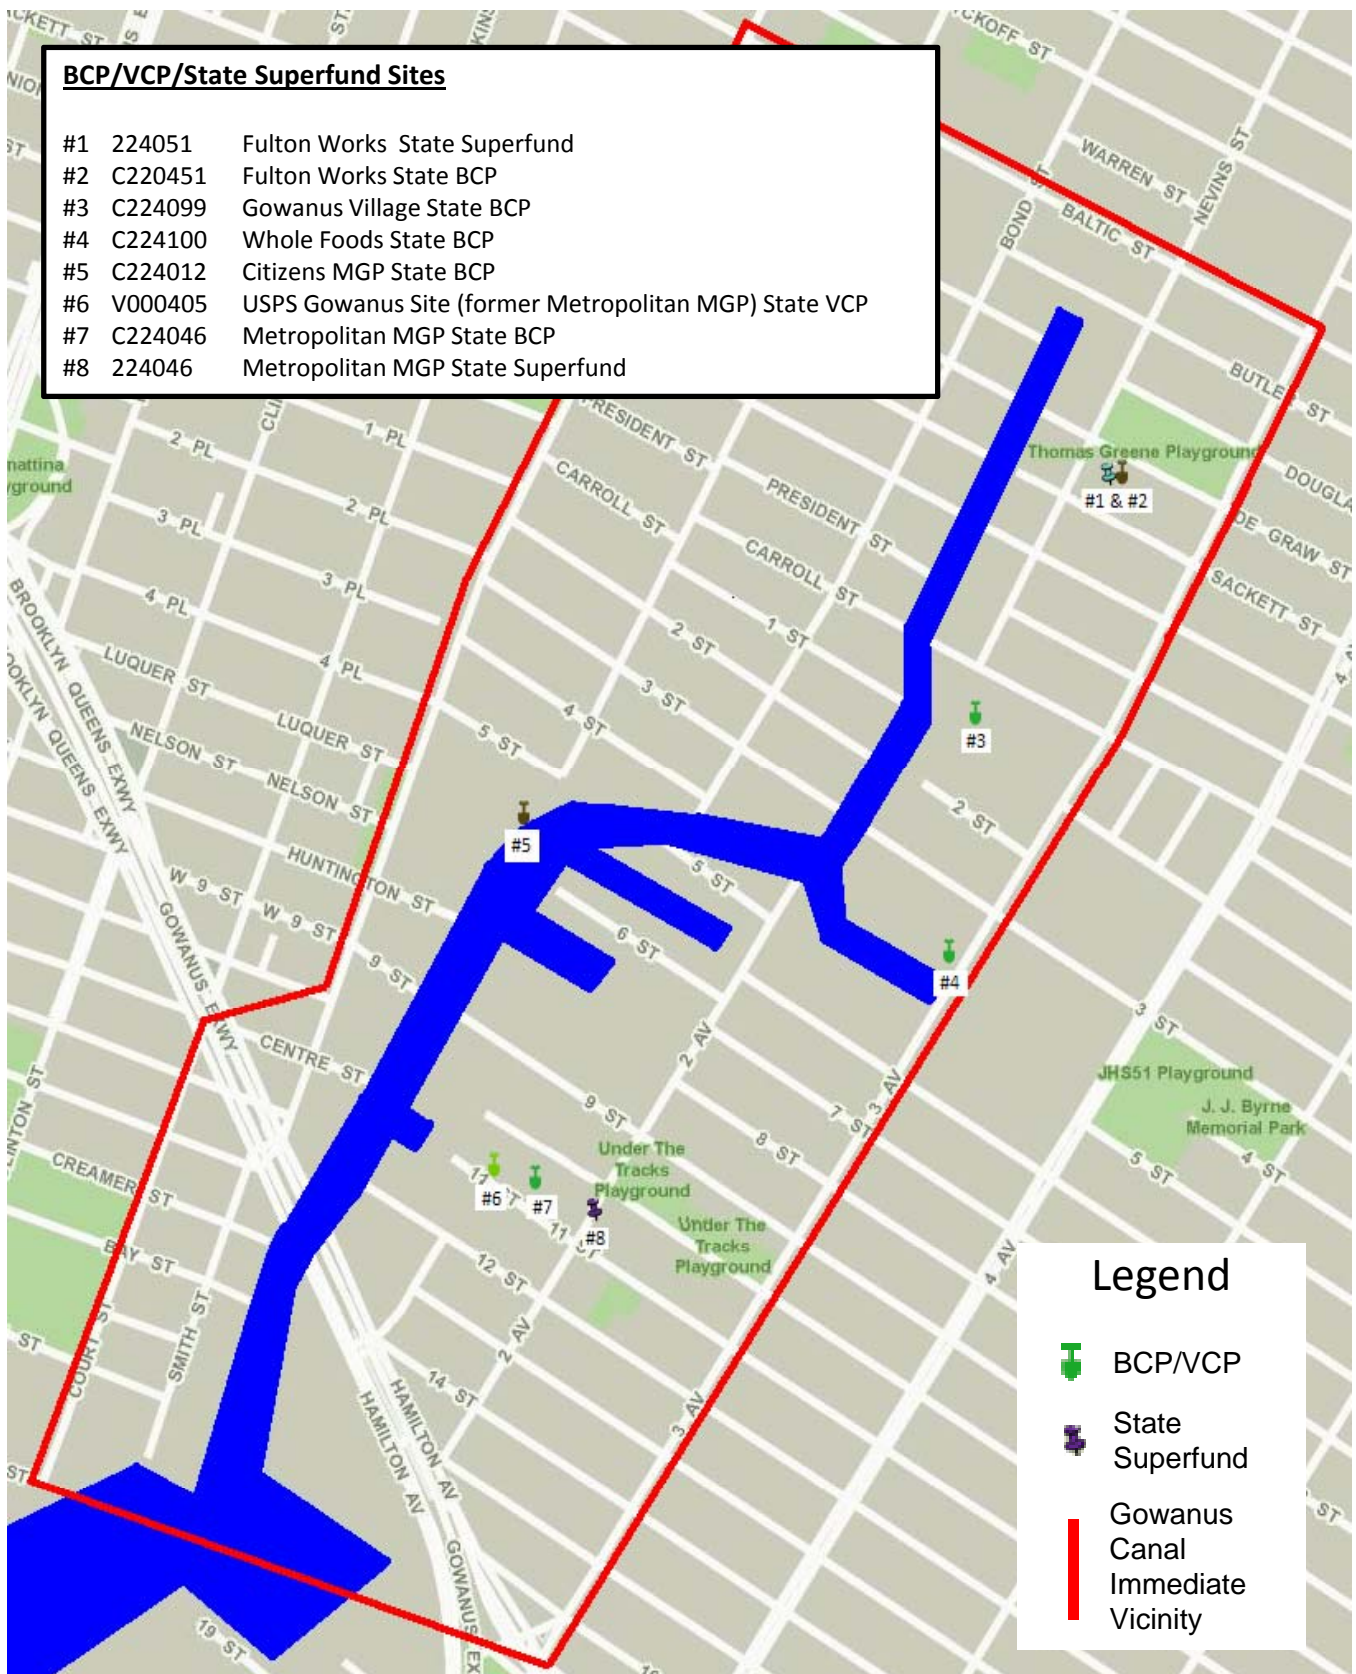
Figure 6 - NYSDEC BCP, VCP, & State Superfund Sites Near Gowanus Canal

The NYS Inactive Hazardous Waste Program, informally known as the NYS Superfund Program, addresses listed properties with disposal of consequential amounts of hazardous waste that pose a significant threat to public health and/or the environment (NYS DEC 2007/2008). This program uses a cleanup process that is similar to Federal Superfund and includes the following activities: initial assessment, RI, FS, proposed remedial action plan, a public meeting and public comment period, a record of decision with a responsiveness summary, remedial design, remedial construction, and long-term site management. Based on current information in the NYSDEC database, the following two State Superfund sites have been identified and their locations are shown in Figure 6.
